**LARGE AREA COMPOSITE INSPECTION
SYSTEM LACIS-D**

FINAL REPORT FOR PERIOD SEPTEMBER 1993 to AUGUST 1995

**MATERIALS DIRECTORATE
WRIGHT LABORATORY
AIR FORCE MATERIEL COMMAND
WRIGHT PATTERSON AFB OH 45433- 7734**

| REPORT DOCUMENTATION PAGE | | | FORM APPROVED OMB NO. 0704-0188 | |
|---|---|---|---|---|
| 13. ABSTRACT (Maximum 200 words) The purpose of this program was to conduct the advanced development, integration, modification, and demonstration of a large area nondestructive inspection technique for the rapid detection and quantification of material properties and defects in large fiber-reinforced composite aircraft compoents. | | | | |

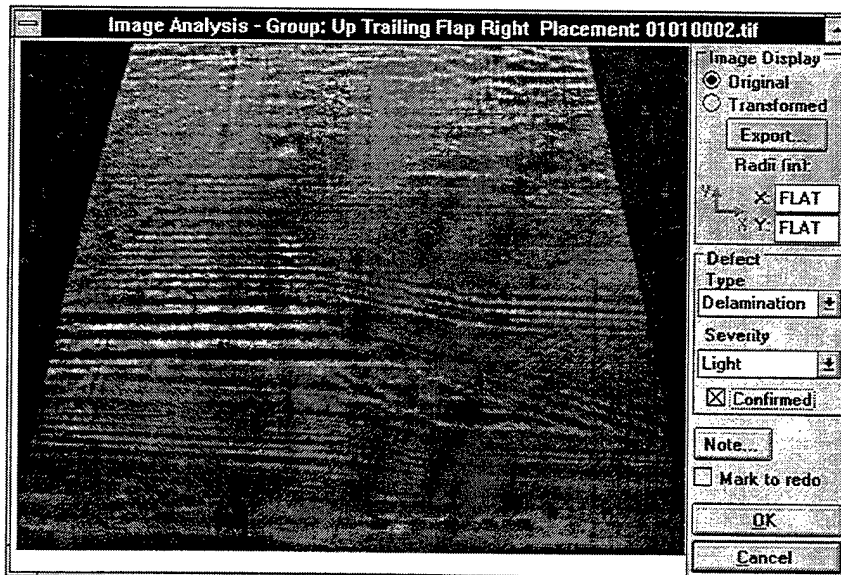
The critical display of the image is provided in a dialog box shown in 73. If the image in the placement box indicates corrosion and is marked accordingly, the placement box is marked in red on the turtle diagram on exit with an OK. The aircraft work file is then updated with the defect type and severity. If no corrosion is found, the placement box is marked with green on exit with an OK.

Figure 40: Analysis Dialog Box for Viewing and Marking Defects
